Approval No: **E24 16R-060086**

ECE TYPE-APPROVAL CERTIFICATE

Communication concerning the approval granted of a type of safety belt or restraint system for adult occupants of power driven vehicles pursuant to Regulation No. 16.

PARTIAL MODEL INFORMATION DOCUMENT NO.: HN-200-1 V00

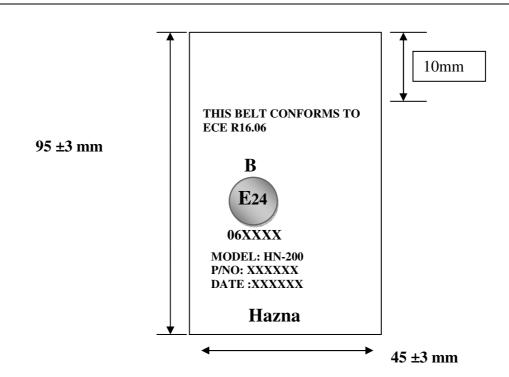
Drawing No.: HN-200-1-003

Label

: Label sewed on the belt,

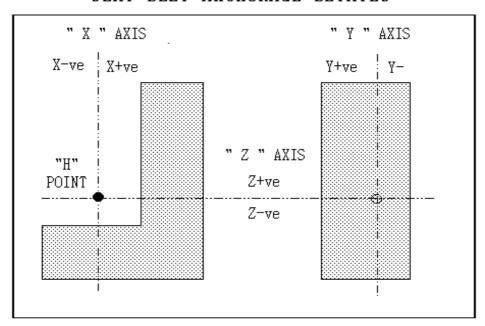
SEAT BELT ANCHORAGE DETAILS

"X" - Axis	"Y" - Axis	"Z" - Axis
Buckle	50	230	-210
Lower anchorage	180	-240	-160
